Ichthys Gas Field Development Project: Gunn Reef Blue Holes  
and Howard River—water quality and coral survey

28 MARCH 2011

Prepared for  
INPEX Browse, Ltd.

INPEX Document No. C036-AH-REP-0117 Rev 0

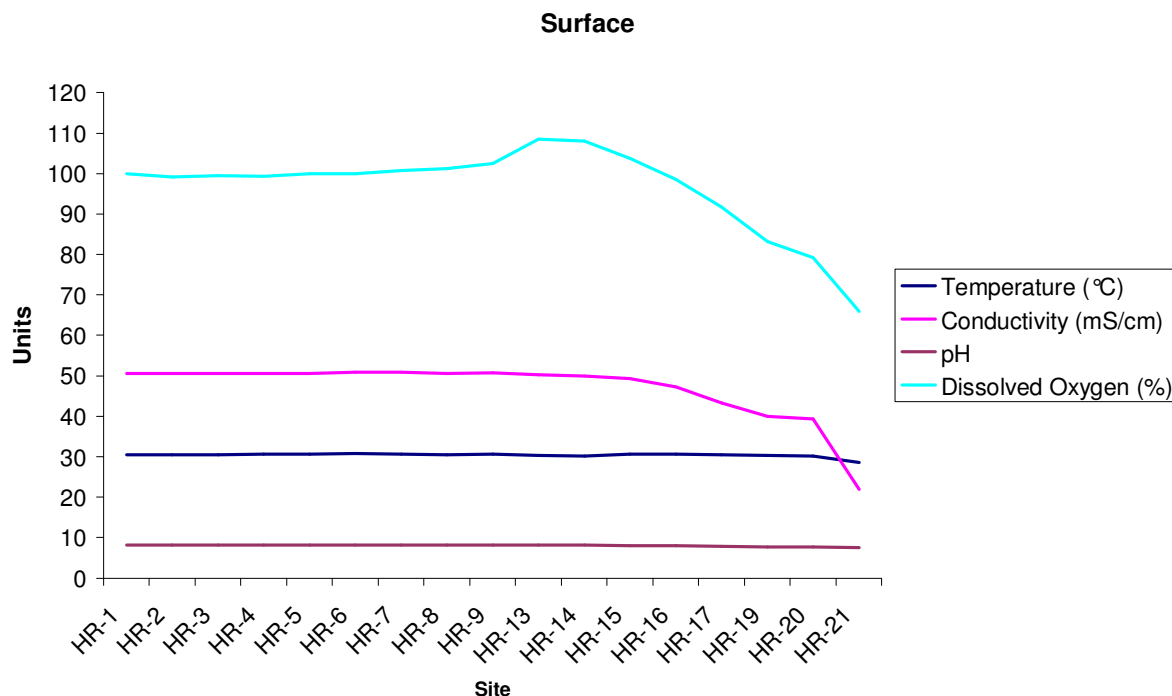
**Figure 3-1 Surface water physico-chemical parameters, Howard River / Hope Inlet system, neap flood tide, 1 December 2010**

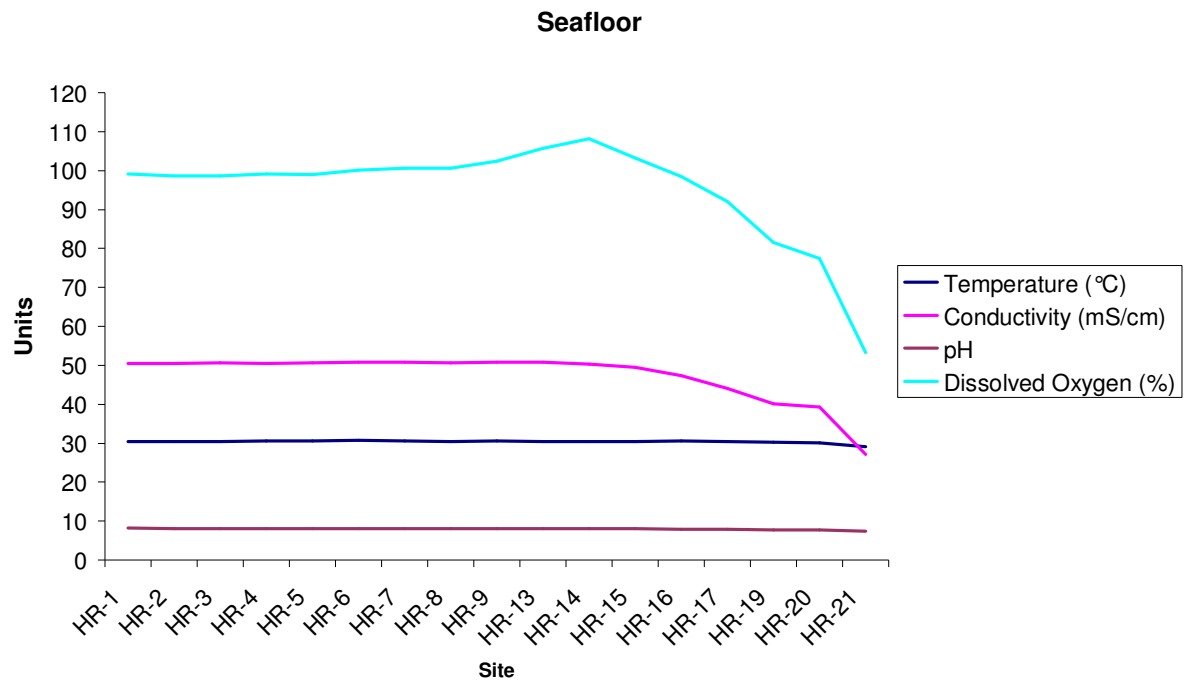
**Figure 3-2** Near-seafloor water physico-chemical parameters, Howard River / Hope Inlet system, neap flood tide, 1 December 2010

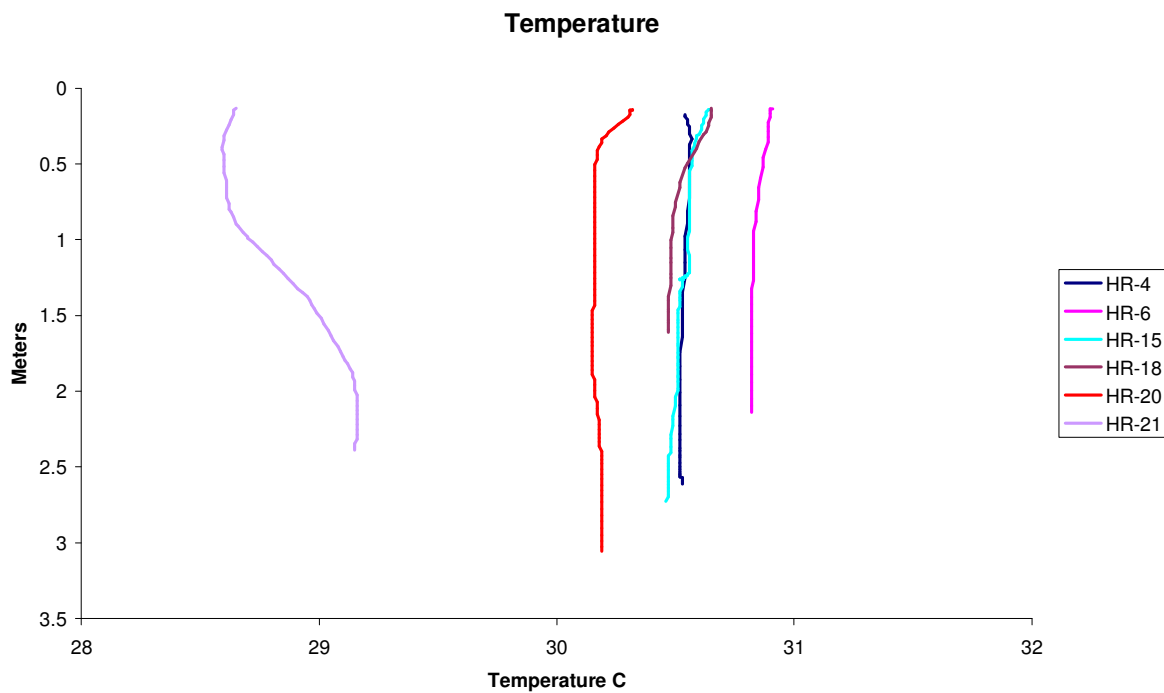
Figure 3-3 Temperature profiles in Howard River / Hope Inlet system, neap flood tide, 1 December 2010

Figure 3-3 shows temperature profiles from selected sites within the Howard River / Hope Inlet system. A slight decrease in temperature is apparent between site HR-6 (within Hope Inlet) and site HR-20 (mid No Hope Creek), with a more marked decrease (approximately 1.5°C) between sites HR-20 and HR-21 (in the upper reaches of No Hope Creek). The lower temperature at HR-21 is associated with fresh water at this site (see following section). Limited stratification with depth was evident in the profiles at some of the sites (e.g. HR-21, Figure 3-3) but no thermoclines (marked changes in temperature over a small depth range) were detected.

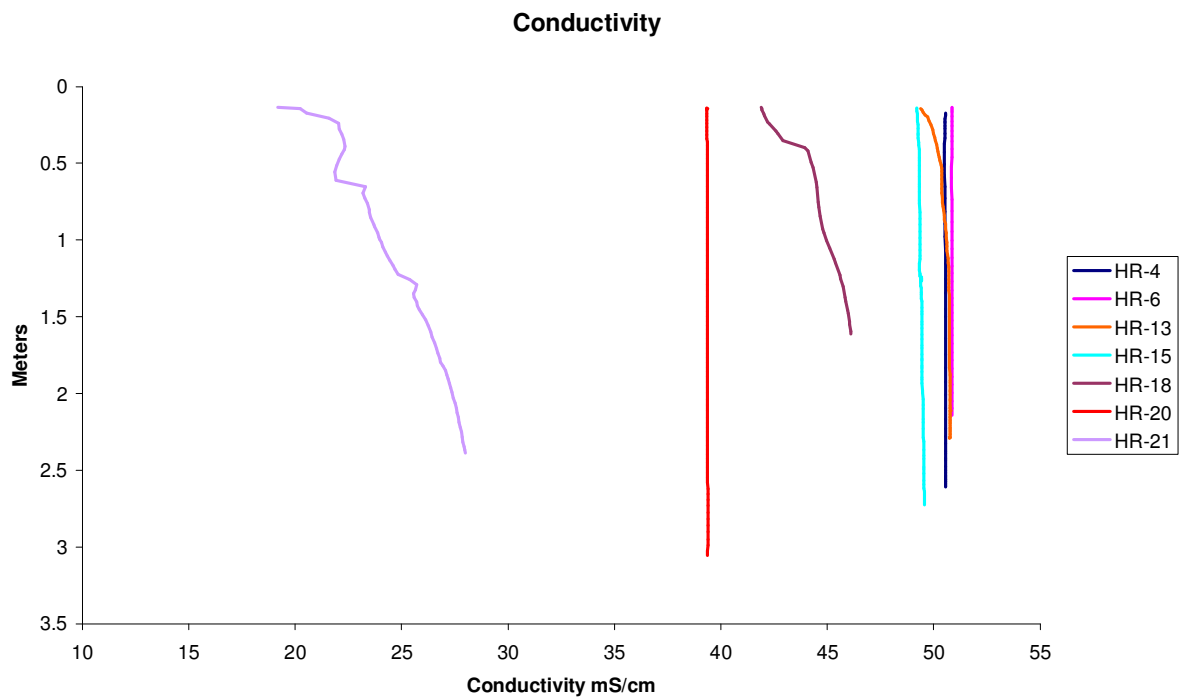
Figure 3-4 Conductivity profiles in Howard River / Hope Inlet system, neap flood tide, 1 December 2010

Analysis of results indicated a strong decreasing trend in conductivity levels between mid Hope River (site HR-13) and the upper reaches of No Hope Creek (site HR-21) (Figures 3-1, 3-2 and 3-4). Conductivity levels recorded between the Howard River mouth and mid Hope River (HR-1 to HR-9) varied little, indicating the lower reaches of the system are well mixed. Stratification was present in some profiles from mid Hope River to No Hope Creek, with lower conductivity levels recorded at the surface and increasing conductivity with depth (e.g. sites HR-18 and HR-21, Figure 3-4).

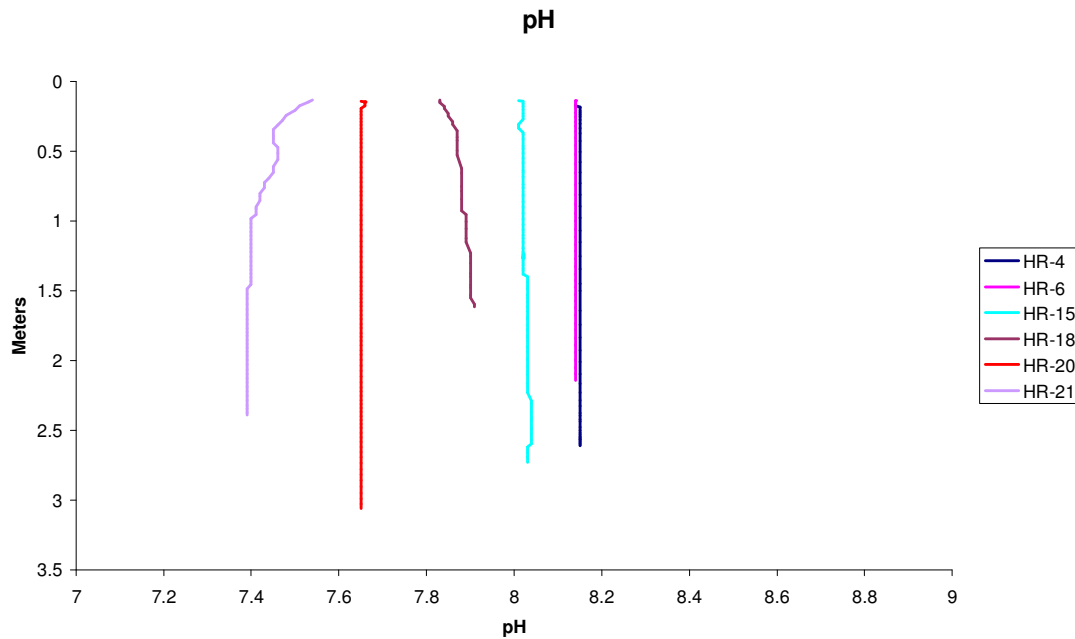
Figure 3-5 pH profiles in Howard River / Hope Inlet system, neap flood tide, 1 December 2010

There was a slight decreasing trend in pH values with distance upstream from the mouth (Figure 3-5), which may have been associated with fresh water flowing in from upstream. No stratification with depth occurred at any of the sampling locations, and pH was typically uniform throughout the profile (Figure 3-5).

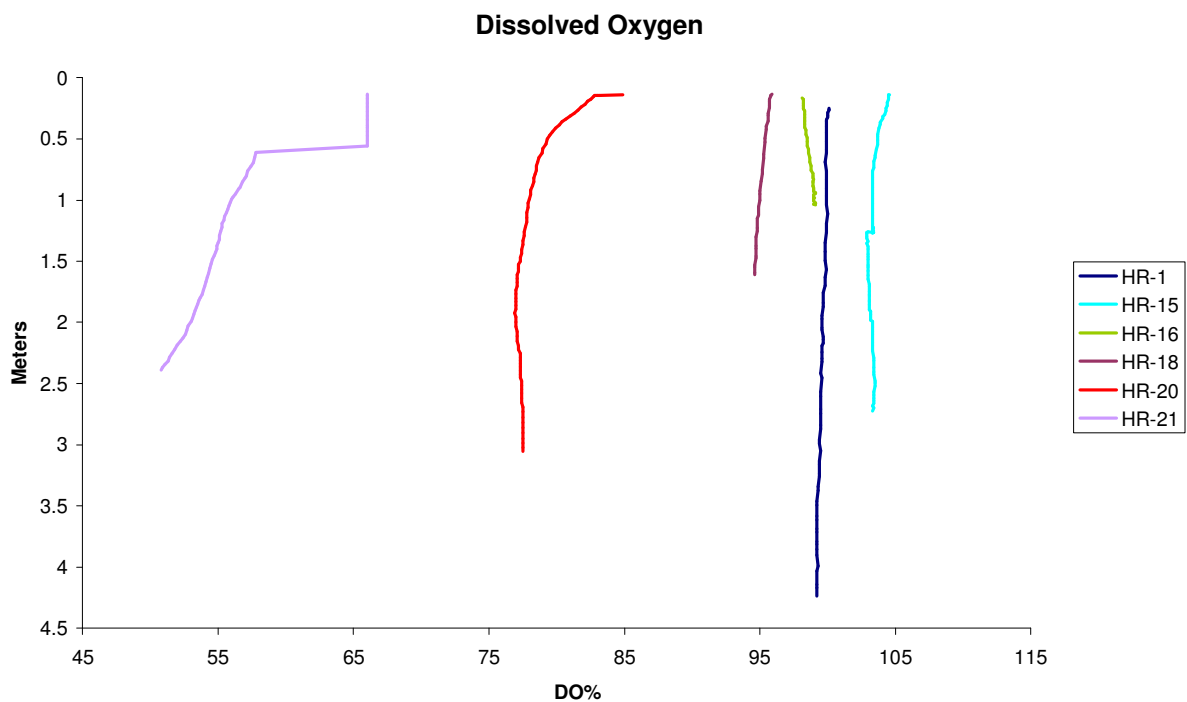
Figure 3-6 Dissolved Oxygen profiles in Howard River / Hope Inlet system, neap flood tide, 1 December 2010

Figure 3-6 shows profiles of dissolved oxygen (as percentage saturation, DO%) at selected sites within the Howard River / Hope Inlet system. DO% followed a similar pattern as conductivity, with sites between Howard River mouth (HR-1) and mid Hope River (HR-15) sharing similar characteristics (99-105%) and sites between mid Hope River (HR-16) and No Hope Creek (HR-21) showing a decrease in DO% with distance upstream (Figures 3-1, 3-2 and 3-6). The marked reduction in DO% below 0.6 m at site HR-21 coincided with a slight increase in conductivity, indicating that the fresher surface water layer was more highly oxygenated than the underlying brackish water.

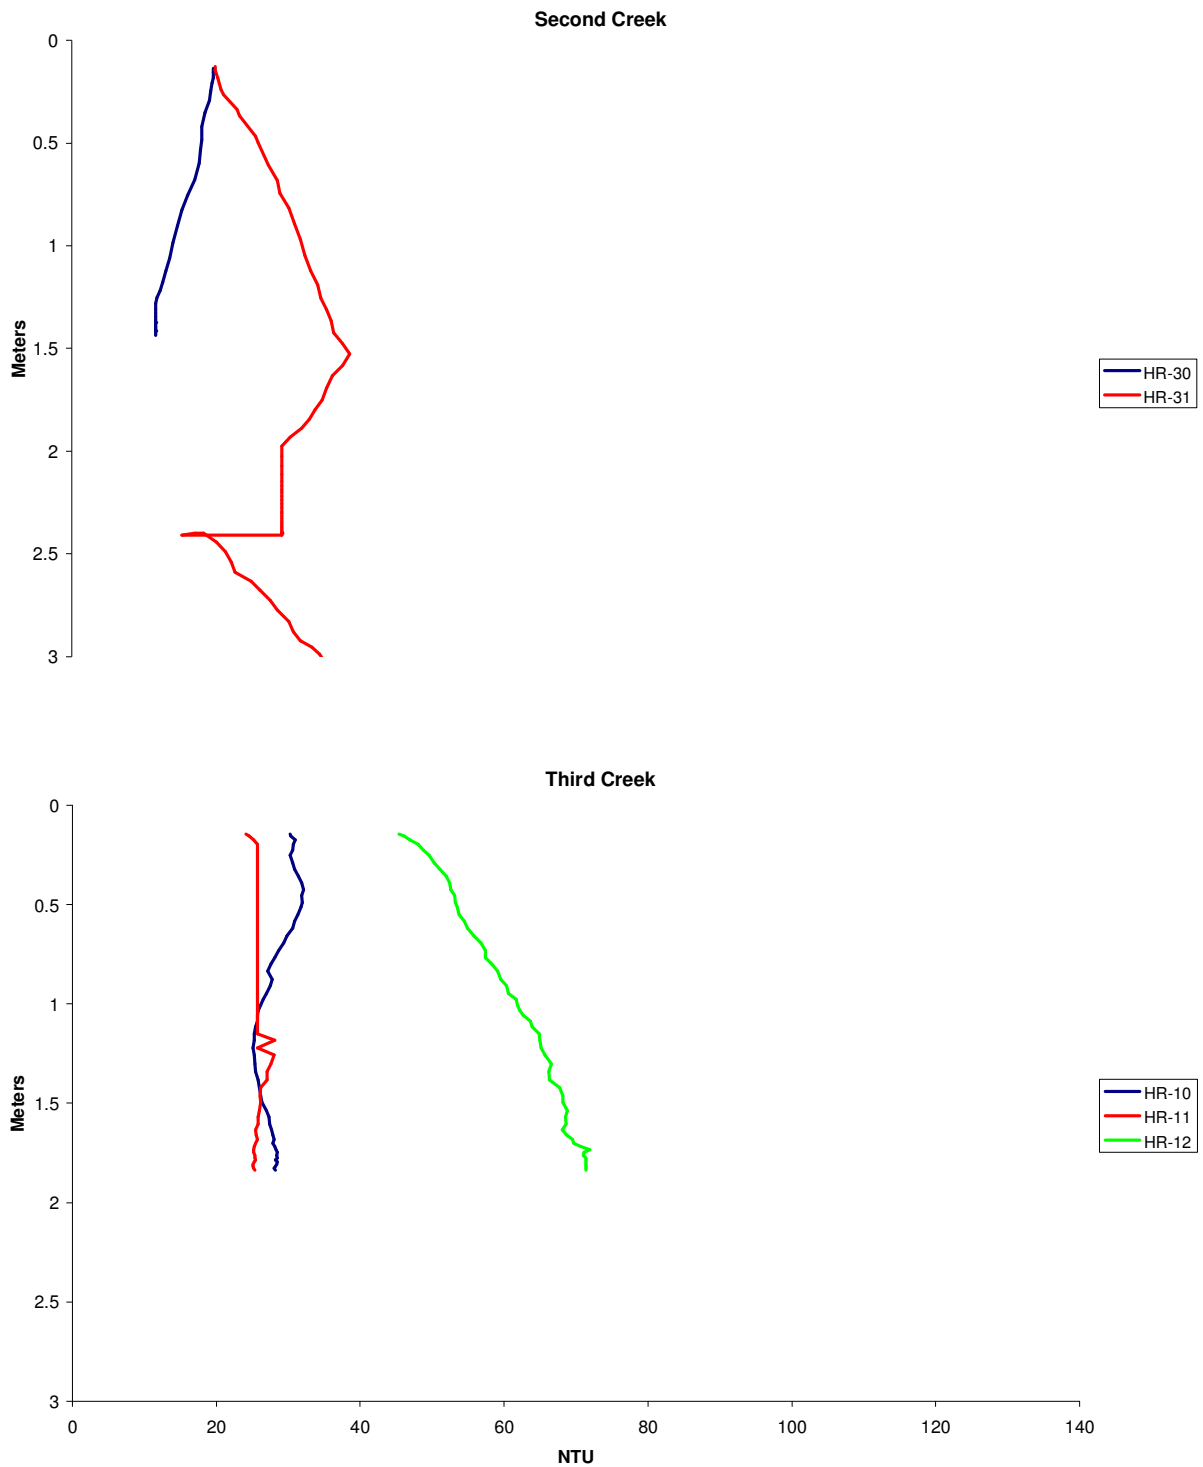
Figure 3-9 Second Creek and Third Creek turbidity profiles, neap flood tide, 1 December 2010

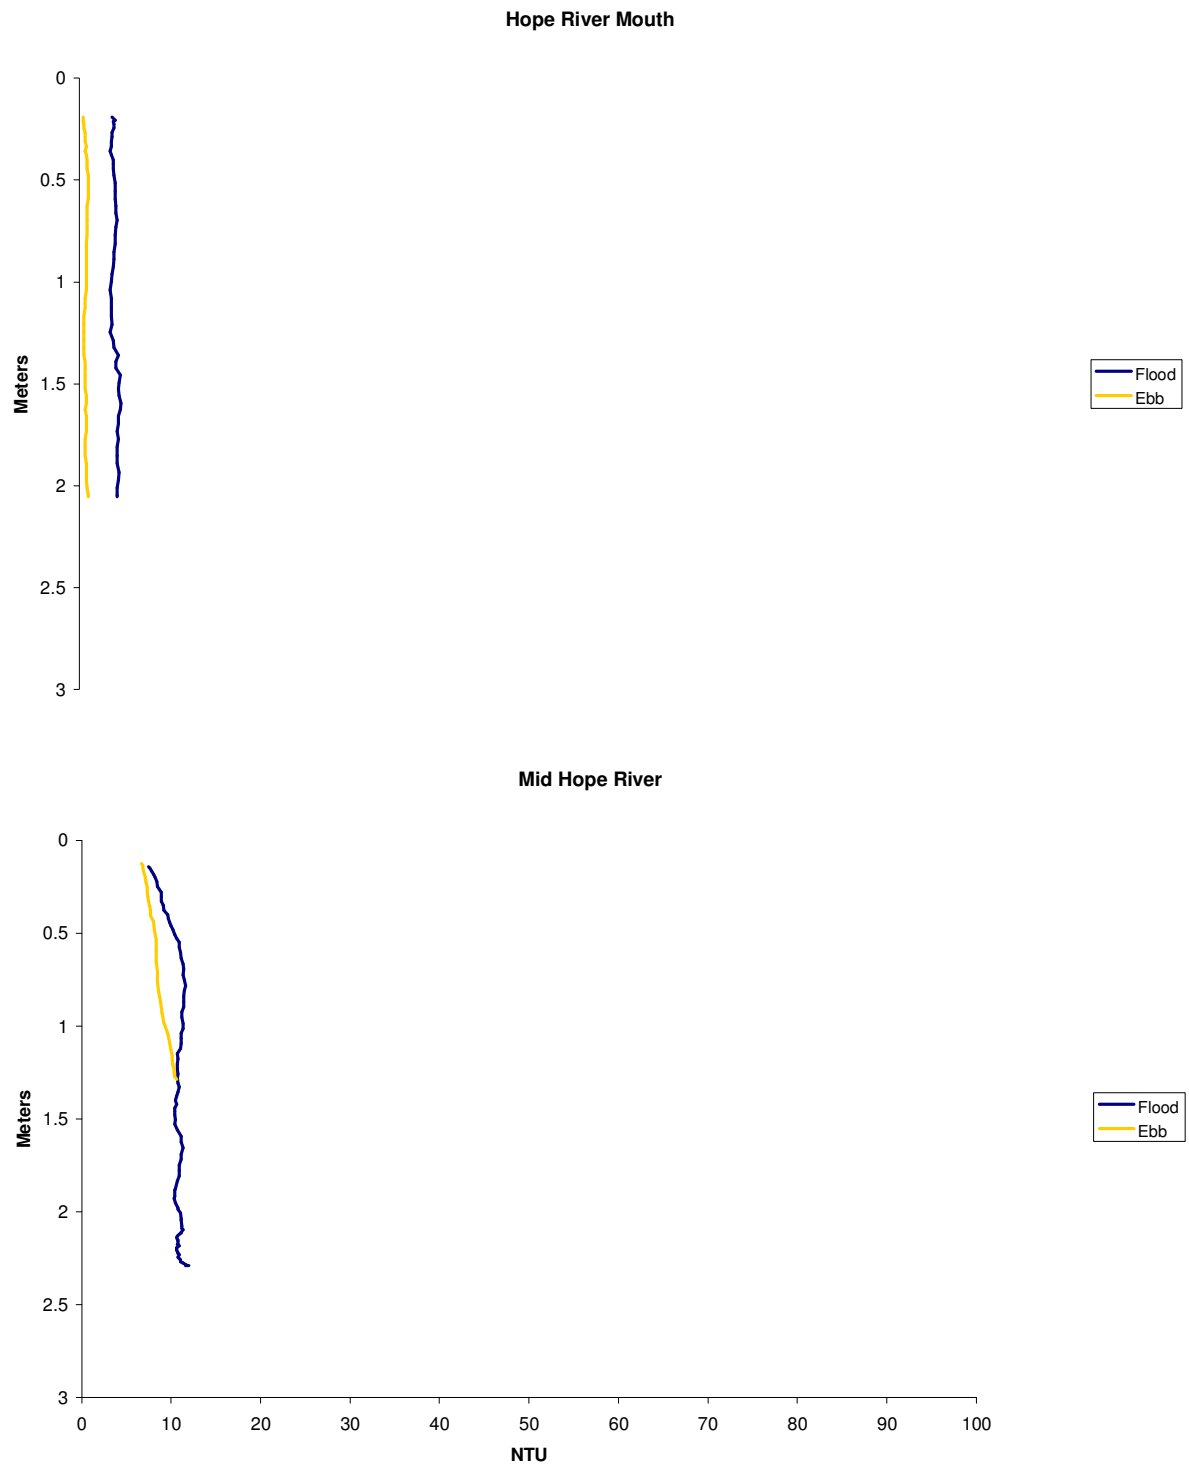
**Figure 3-10** Howard River and Mid Hope River turbidity profiles, measured before and after high tide during a neap tide cycle, 1 December 2010

Note: Large scale of X-axis is to permit easy comparison between profiles in Figures 3-10 and 3-11.

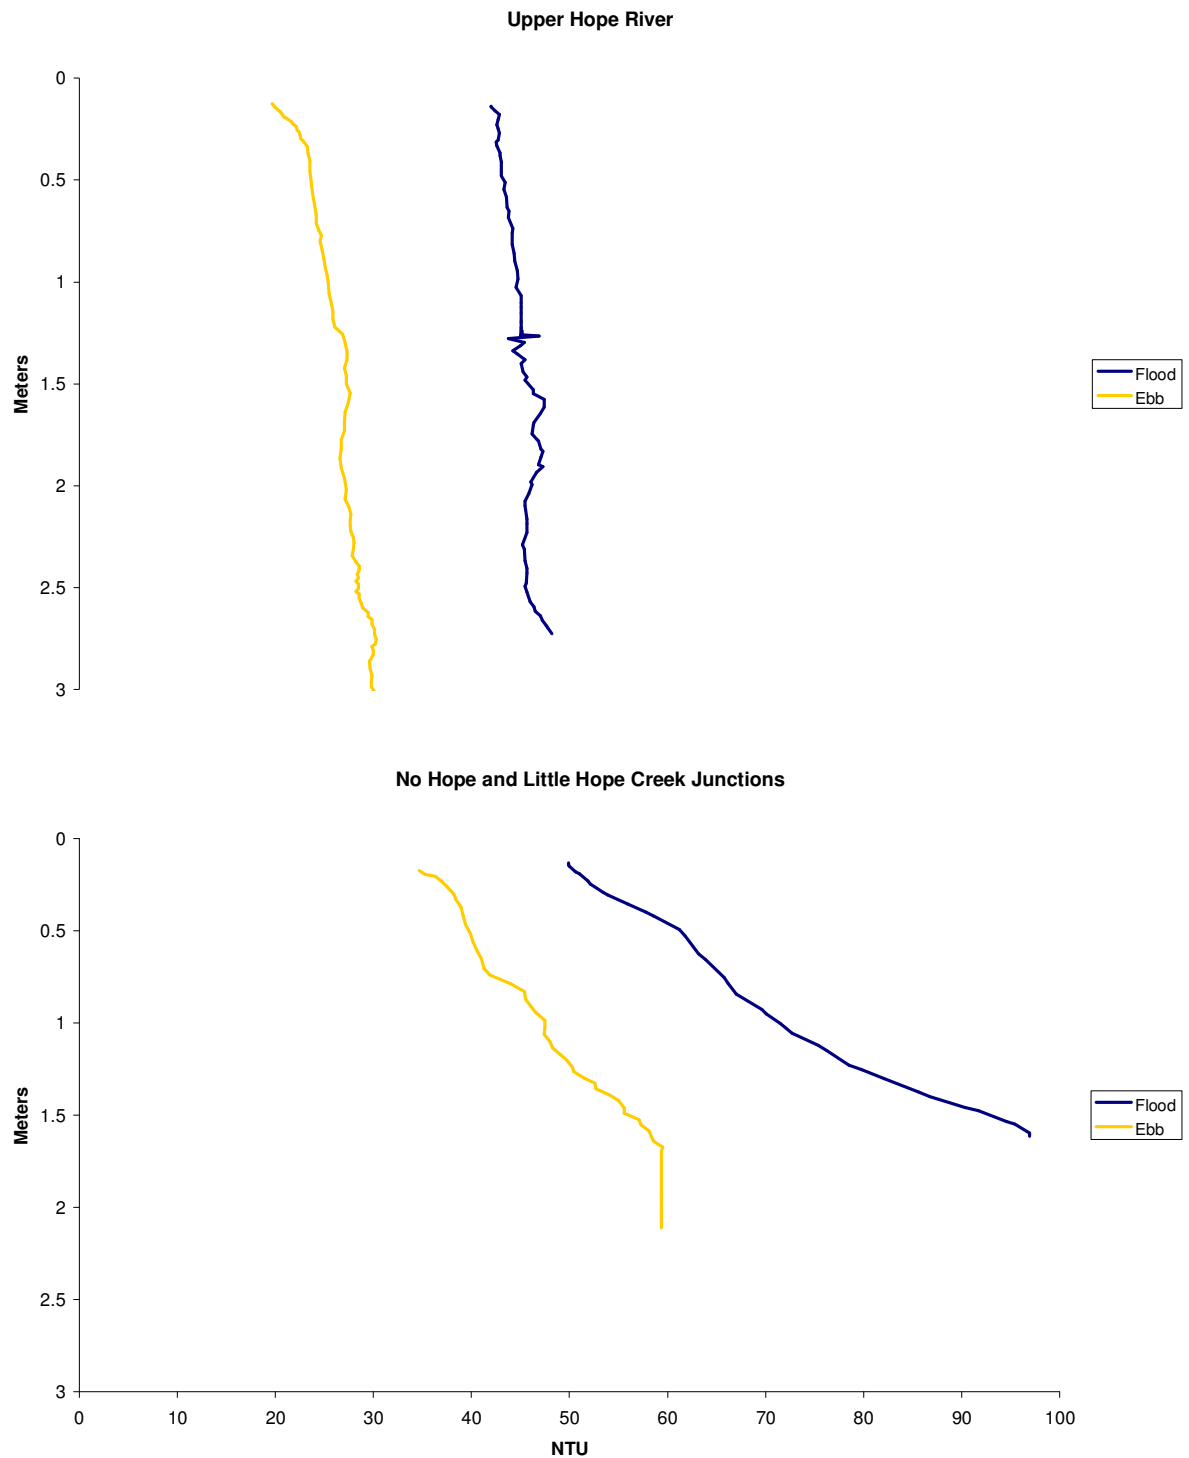
Figure 3-11 Upper Hope River and Creek junction turbidity profiles, measured before and after high tide during a neap tide cycle, 1 December 2010

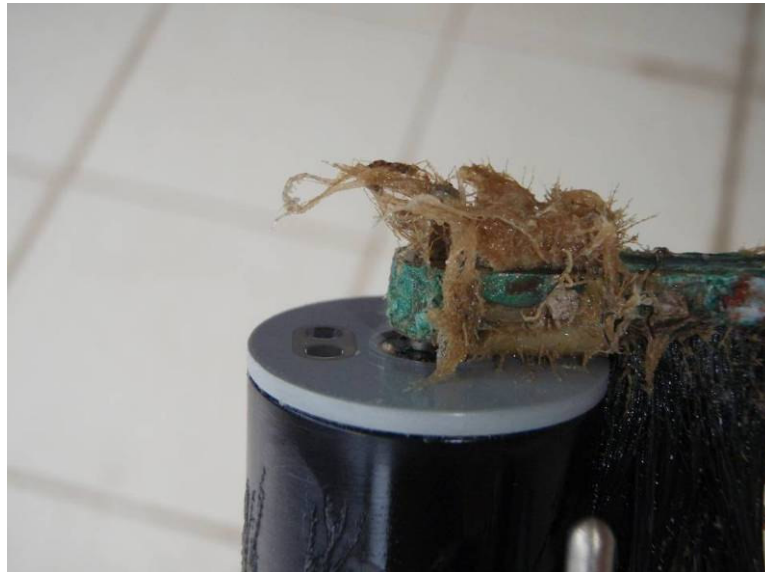
**Plate 3-1** Extended deployment logger probe and wiper assembly displaying heavy fouling after 28 days at Howard River mouth

Data were recorded between 1 and 28 December 2010, with a total of 2590 data points logged. All parameters were recorded by the sonde for the full duration of deployment, though heavy marine growth around the sensors and wiper units (Plate 3-1) caused data anomalies from around 11 days post-deployment through to the retrieval date. As a result, all data from this day forward were omitted from analysis.

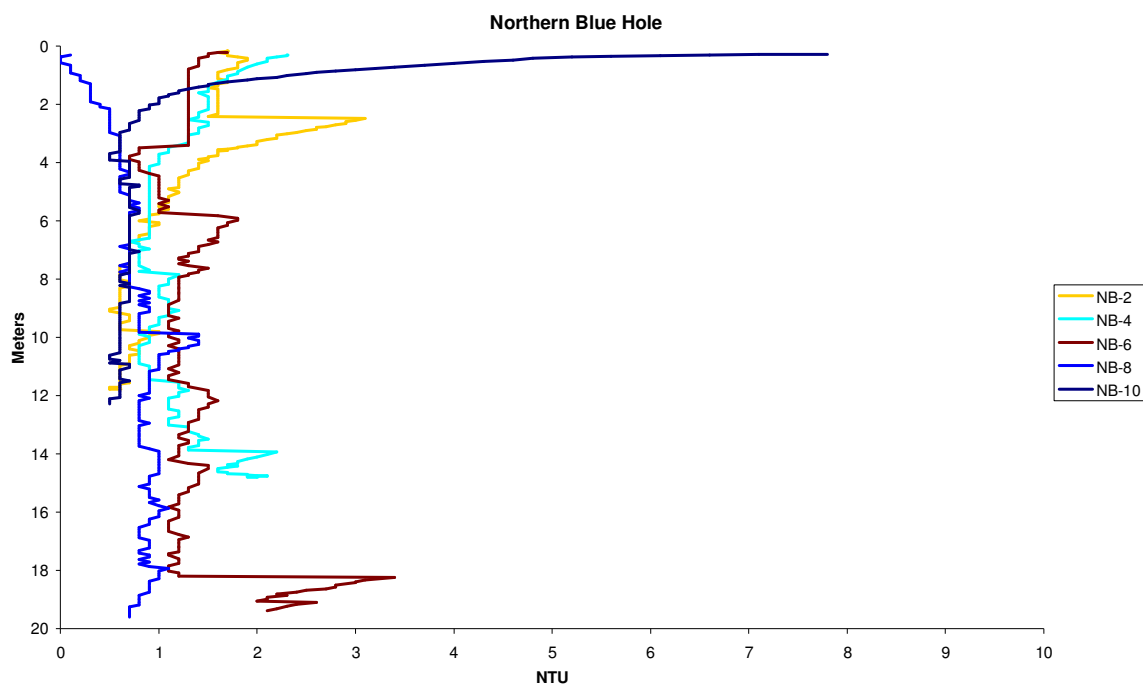
Figure 3-13 Northern Blue Hole turbidity profiles, spring ebb tide, 7 December 2010

- **Turbidity** levels within the system were low with 75% of values below 2 NTU and a mean of 1.1 NTU (Table 3-5). A maximum level of 7.8 NTU was recorded on the flood tide in the surface water layer at site NB-10 (Figure 3-13), most likely indicating the incursion of slightly more turbid water from outside of the NBH. Few variations were recorded with depth, or between sampling locations. During the low water period, when the NBH was landlocked and isolated from the surrounding waters and tidal currents were low, repeated measurements taken at sites NB-1 to NB-6 showed that NTU levels decreased slightly (generally by <2 NTU, Figure 3-14) as suspended sediments settled out of the water column.

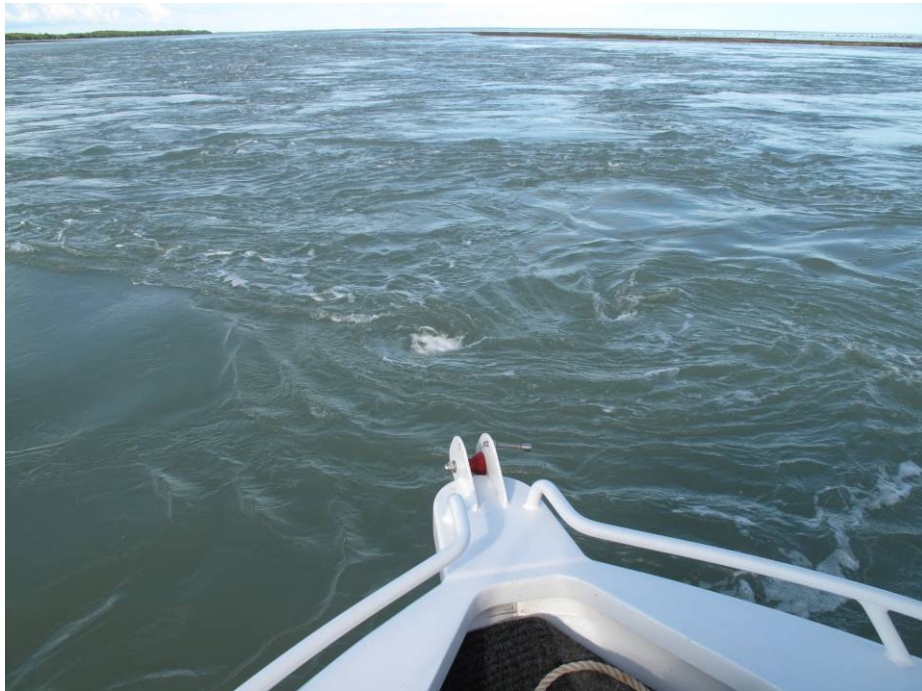
**Plate 3-2** Turbulent currents produced by spring flood tide flowing through eastern entrance to Southern Blue Hole, 8 December 2010

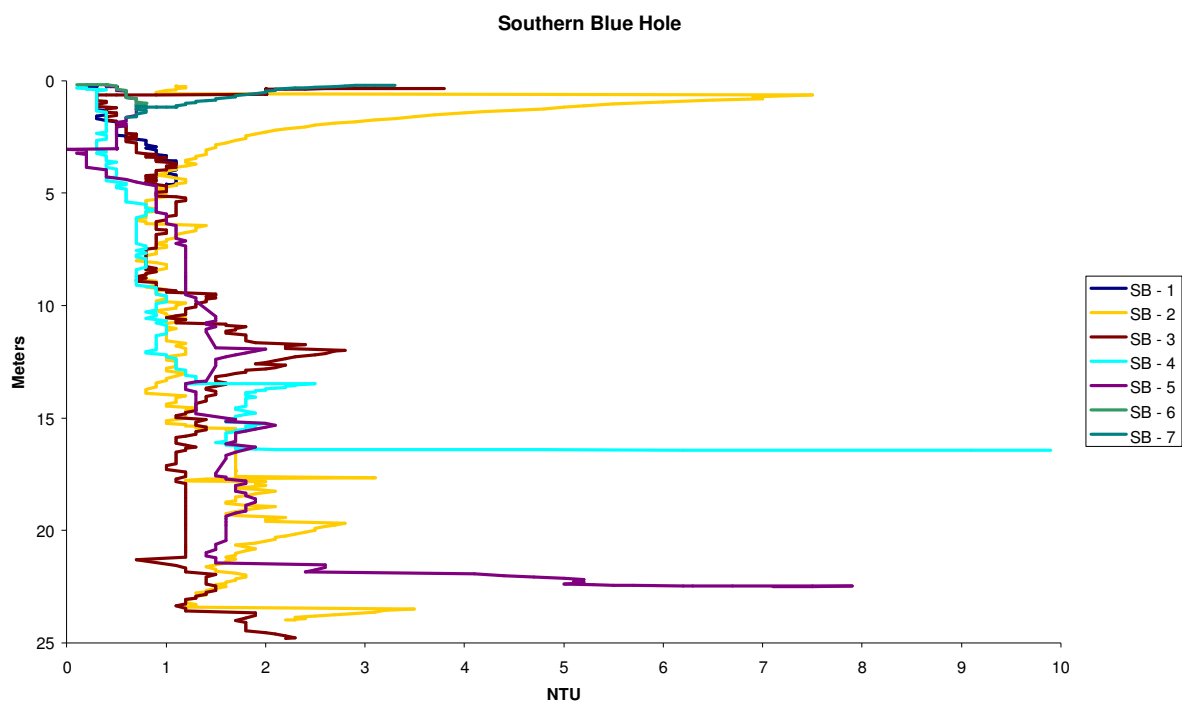
Figure 3-15 Southern Blue Hole turbidity profiles recorded at ebb tide during a spring tide cycle

As expected, turbidity levels within the SBH were generally higher than those in the NBH; the SBH is flanked by intertidal mudflats, supporting an almost continuous mangrove community around the perimeter, that are potential sources of substantial sediment input under certain meteorological and hydrodynamic conditions. In contrast, the NBH is incised into a rock platform with only isolated areas of sediment deposition.

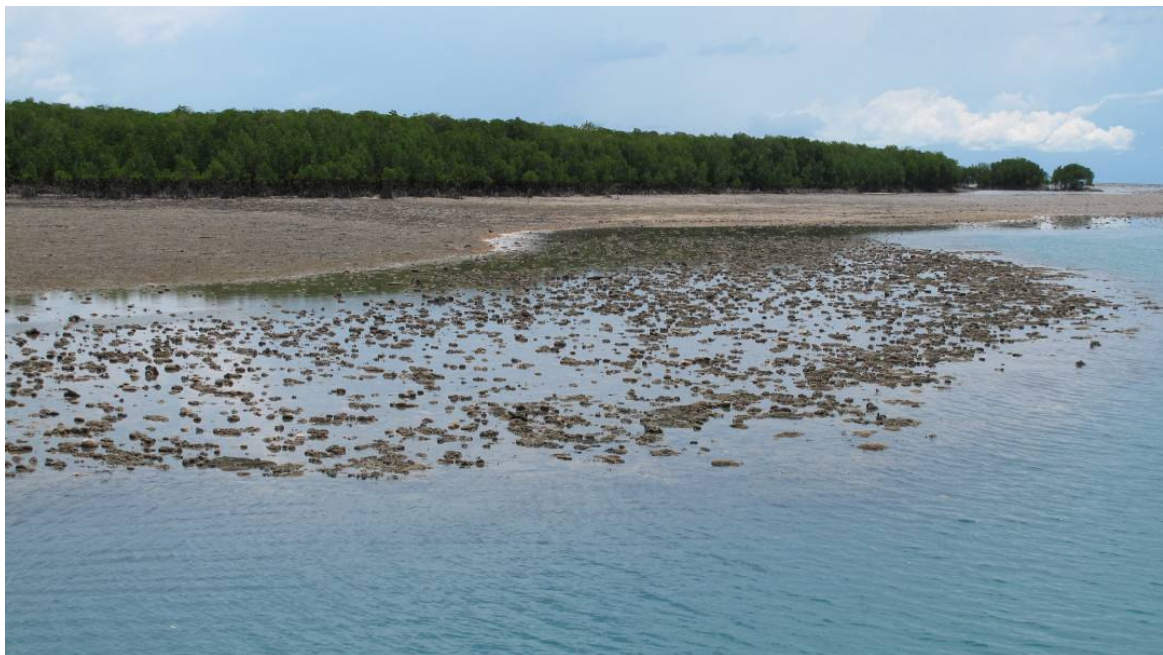
**Plate 3-3 Typical edge of the Northern Blue Hole showing partially exposed high *Acropora* cover extending onto reef flat**

A narrow band of high cover (60-80%) monogeneric stands of tabulate and corymbose (short branching) *Acropora* colonies extend some 10-50 m from the edge of the hole onto the reef flat, around the perimeter of the NBH (Plate 3-3). *Acropora tenuis* and *A. valida* have previously been recorded on the coral reefs at Gunn Point (Wolstenholme et al. 1997). *Acropora* typically grow in an environment of presumed maximum oxygen saturation and light availability (Riegl & Pillar 1997) such as that at the western entrance channel to NBH.

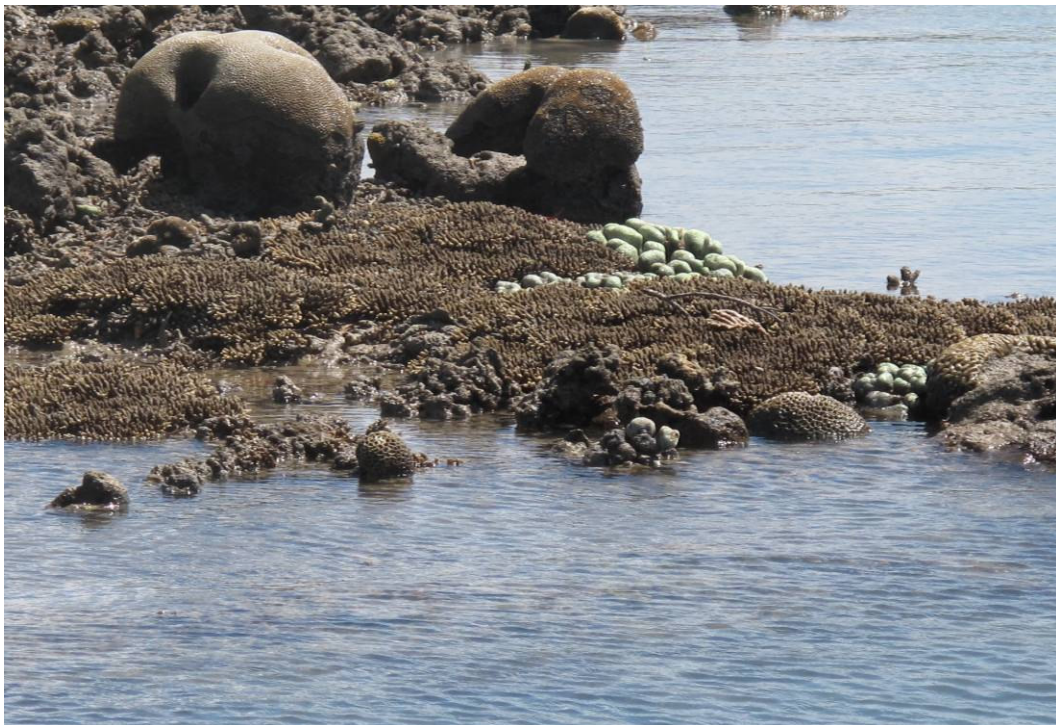
**Plate 3-4** Intertidal coral community (massive Faviids and corymbose *Acropora*) near eastern entrance of Southern Blue Hole

Corals identified in the video transects at the western end (SBHV01 and SBHV02) of SBH included small Faviid genera: *Goniastrea*, *Favia*, *Montastrea* and *Caulastrea*. A central SBH video transect (SBHV03) showed the assemblage was more diverse, although still low in cover. Coral cover was higher along the northern edge of the eastern entrance of SBH (SBHV04), with a higher cover (up to 75%) of tabulate *Acropora* and Faviids (including *Goniastrea*, some of which were partially bleached) on the upper sections of the near-vertical walls, and on the adjacent reef flat (Plate 3-4). A similar community was also present along the southern edge of the entrance. Coral genera identified within the central and eastern transects included a branching Pocilloporid (genus *Stylophora*), encrusting Pectinids (genera *Oxypora* and *Echinophyllia*), massive Faviids (genus *Favites*) and foliose/encrusting Acroporids (genus *Montipora*). The majority of these coral genera, with the exception of *Stylophora*, are generally either found in deeper water or are well adapted to turbid waters (Dikou & van Woesik 2006). *Stylophora* are generally found on reefs exposed to high energy environments (Riegl & Piller 1997).

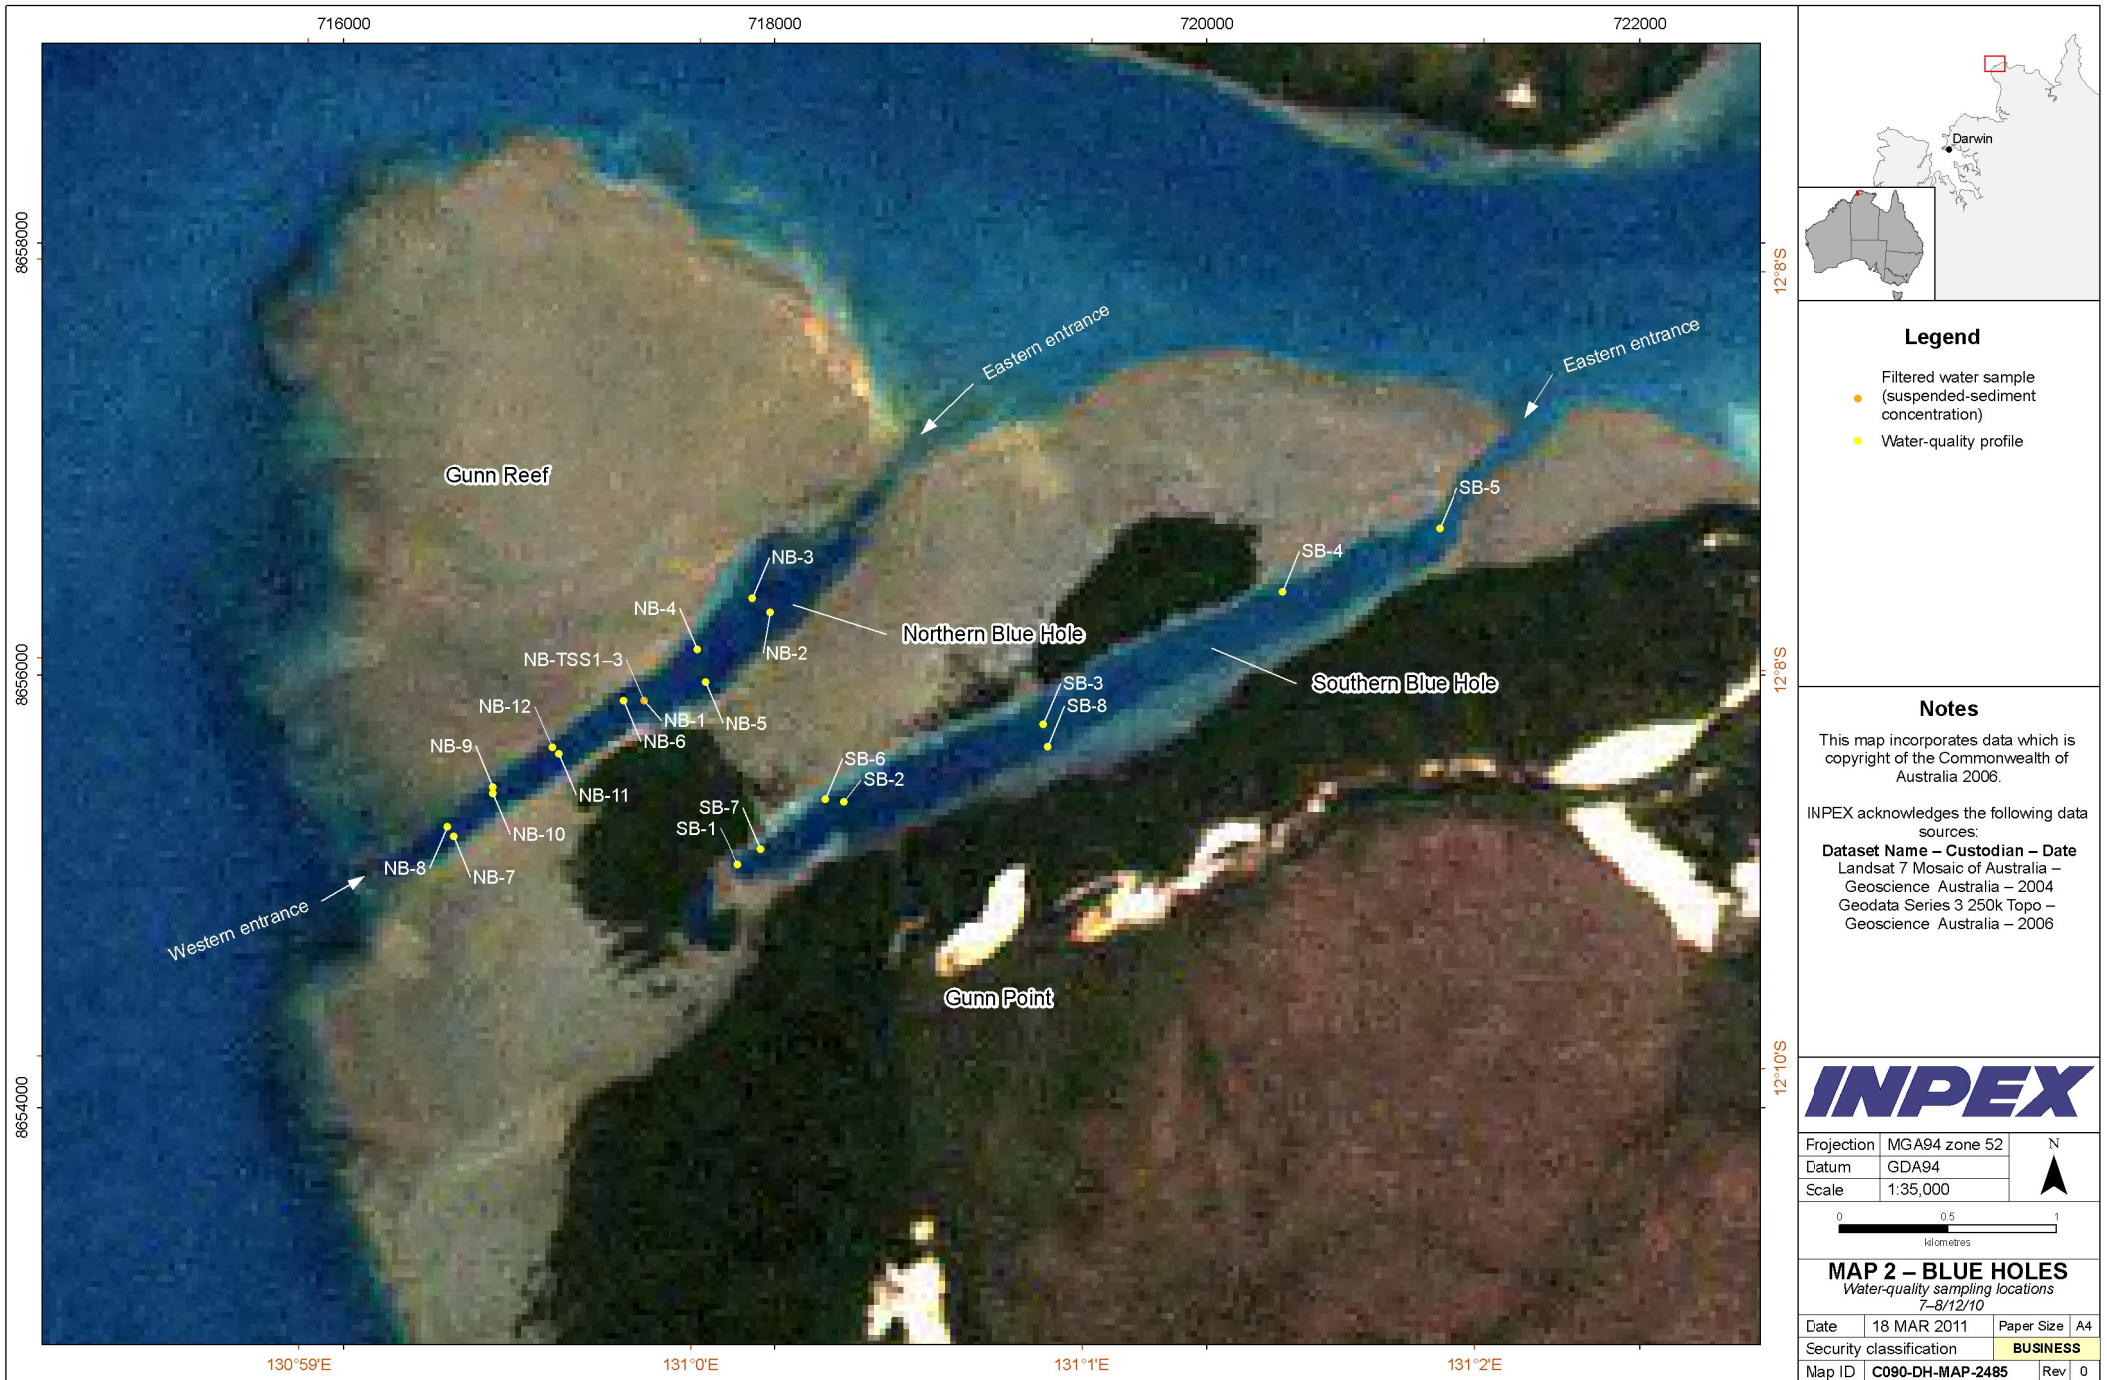
Date	18 MAR 2011	Paper Size	A4
Security classification	BUSINESS		
Map ID	C090-DH-MAP-2484	Rev	0

- Filtered water sample (suspended-sediment concentration)
- Water-quality profile

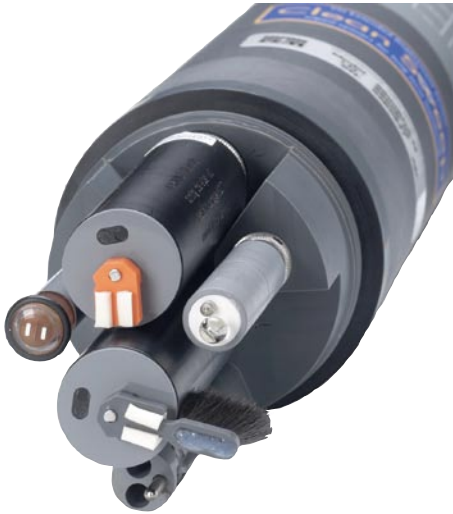
Profile of the 6600EDS depicting (clockwise from bottom) temperature/conductivity, turbidity, Rapid Pulse™ dissolved oxygen, chlorophyll and pH/ORP—all of which (except conductivity) are kept free of fouling by the patented Clean Sweep® universal wiper assembly, as well as individual optical wipers.

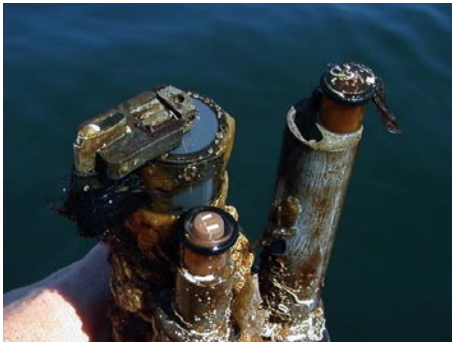
A prototype 6600EDS after continuous deployment for 80 days in Buzzards Bay, MA. The sensor in the foreground is the active DO sensor. The sensor at top-right was used as a non-wiped fouling reference. Note extensive fouling by plant and animal species on the non-wiped sensor.

Initial field studies of the YSI 6600EDS show that the system provides unprecedented DO accuracy and longevity in aggressive fouling environments. The 6600EDS was inspected after 80 days of an ongoing deployment performance evaluation. The Rapid Pulse™ DO sensor performed within specifications throughout this deployment without the need for recalibration or cleaning. During this deployment, the instrument was removed once for battery replacement; none of the sensors was cleaned or recalibrated.
