Ichthys Gas Field Development Project: nearshore development area—assessment of marine heritage survey methods

Assessment of Marine Heritage Survey Methods

Darwin Harbour
Northern Territory

February 2011

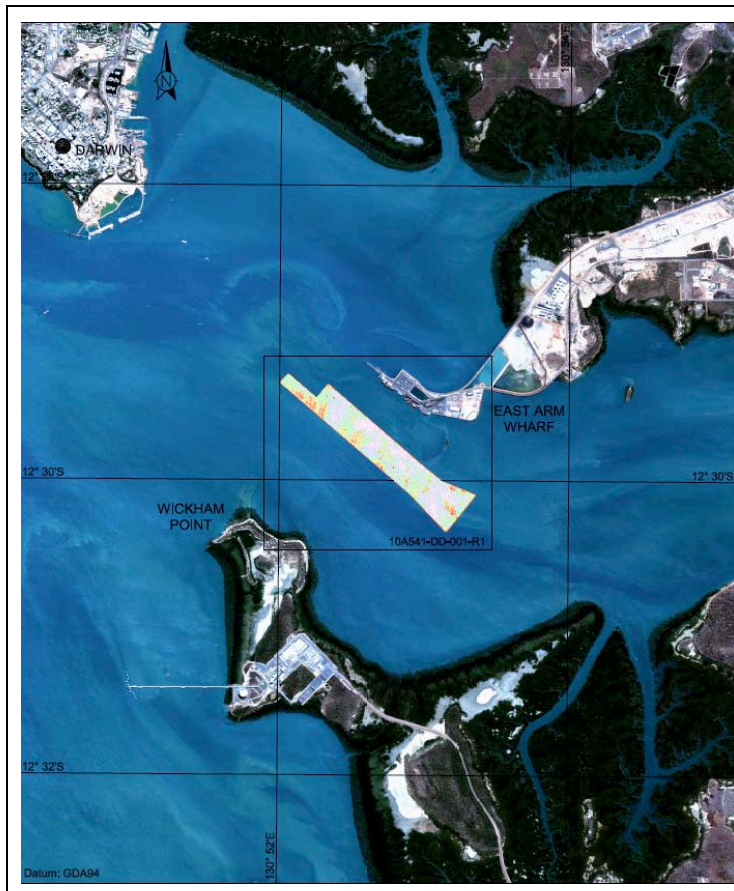
Figure 17 Extent of side scan sonar and gradiometer survey in western portion of Area A undertaken in October/November 2010.

and was towed at 50 m line spacing.⁹⁹ The resolution of the final mosaic was 8 pixels per square metre, translating to a grid resolution of 0.12m.¹⁰⁰

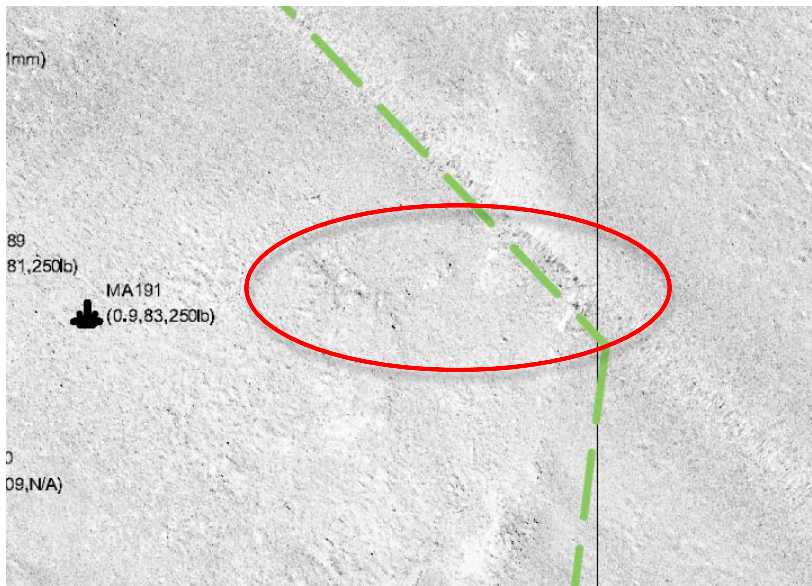
<p>MH 04</p> <p>Description: Appears to be a scatter of low relief debris over 20 m in length to the east of MA191.</p>

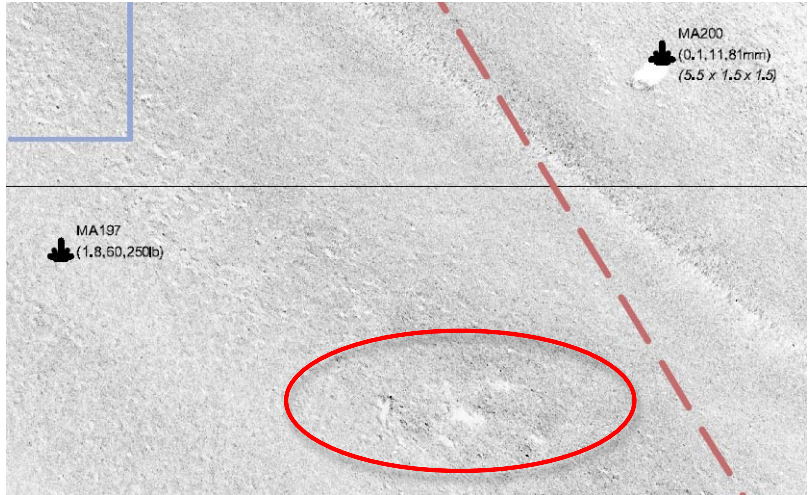
<p>MH 05</p> <p>Description: Appears to be a cluster of low relief debris over 25 m across approximately 50 m to the south - east of MA191.</p>
