EPL228 Annual Environmental Monitoring Report 2022-2023

Document No.: L060-AH-REP-70055
Security Classification: Public

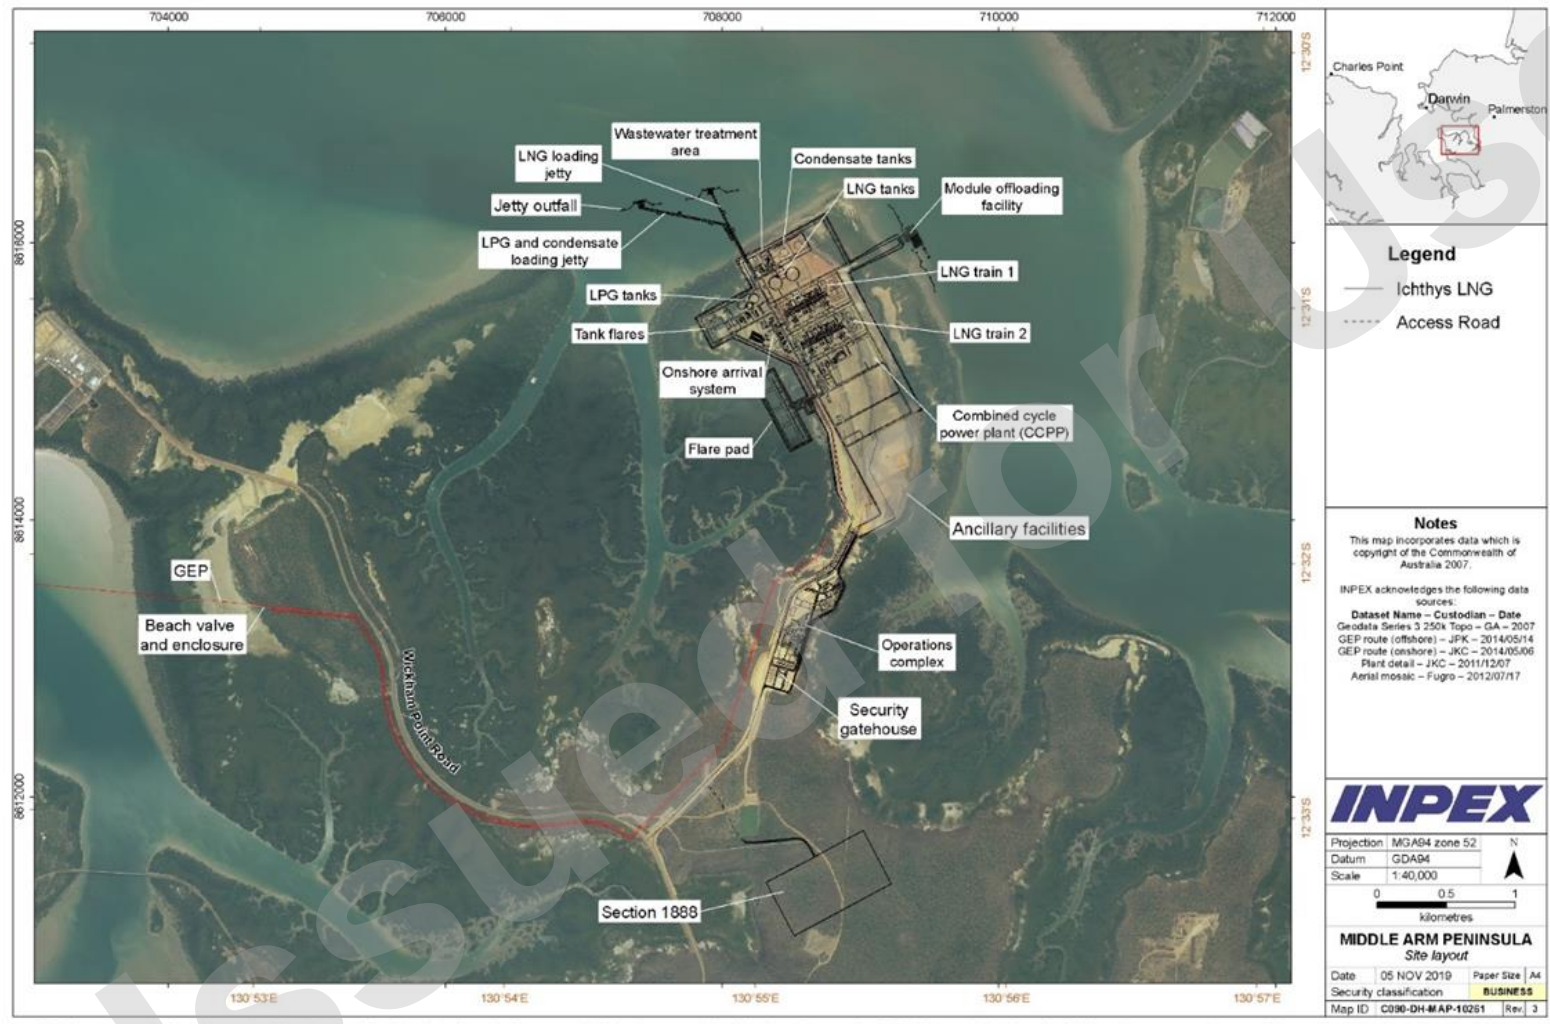
Figure 1-1: Ichthys LNG layout

Table 1-3 provides an overview of the Ichthys LNG key milestones for the reporting period. A general Ichthys LNG site layout is shown in Figure 1-1.

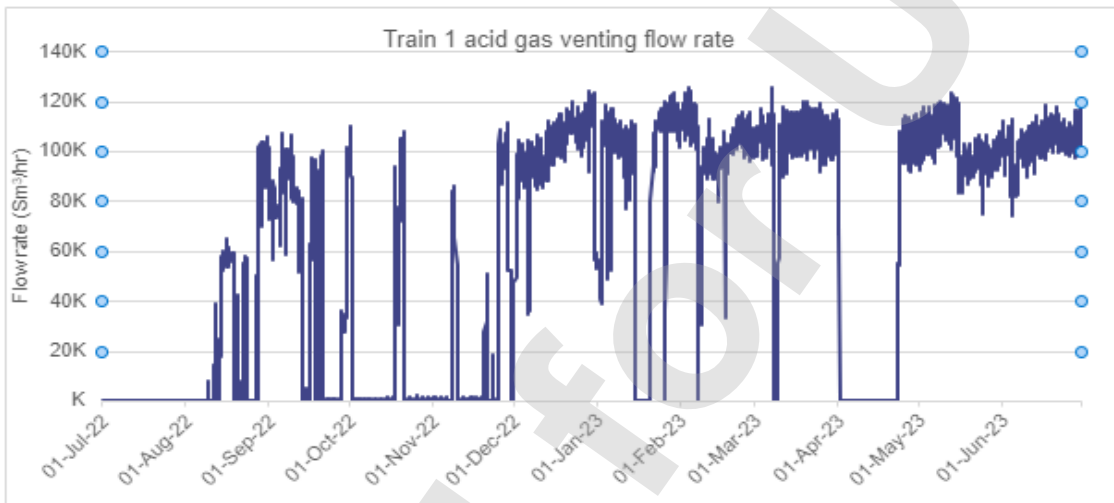
Figure 3-2 Train 1 acid gas venting flow rates

While the acid gas incinerators were offline and venting was occurring, gas sampling was undertaken in accordance with EPL228-5 condition 58.1. In December 2022, Inpex experienced an issue with train 1 & 2 AGI's relating to a valve by-passing hydrocarbons which resulted in a subsequent trip of both AGI's. Both train 1 & train 2 AGI's were taken offline for a full review and Management of Change process before being re-implemented.

At time of writing of this report, Management of Change corrective actions are yet to be finalised prior to coming back online.

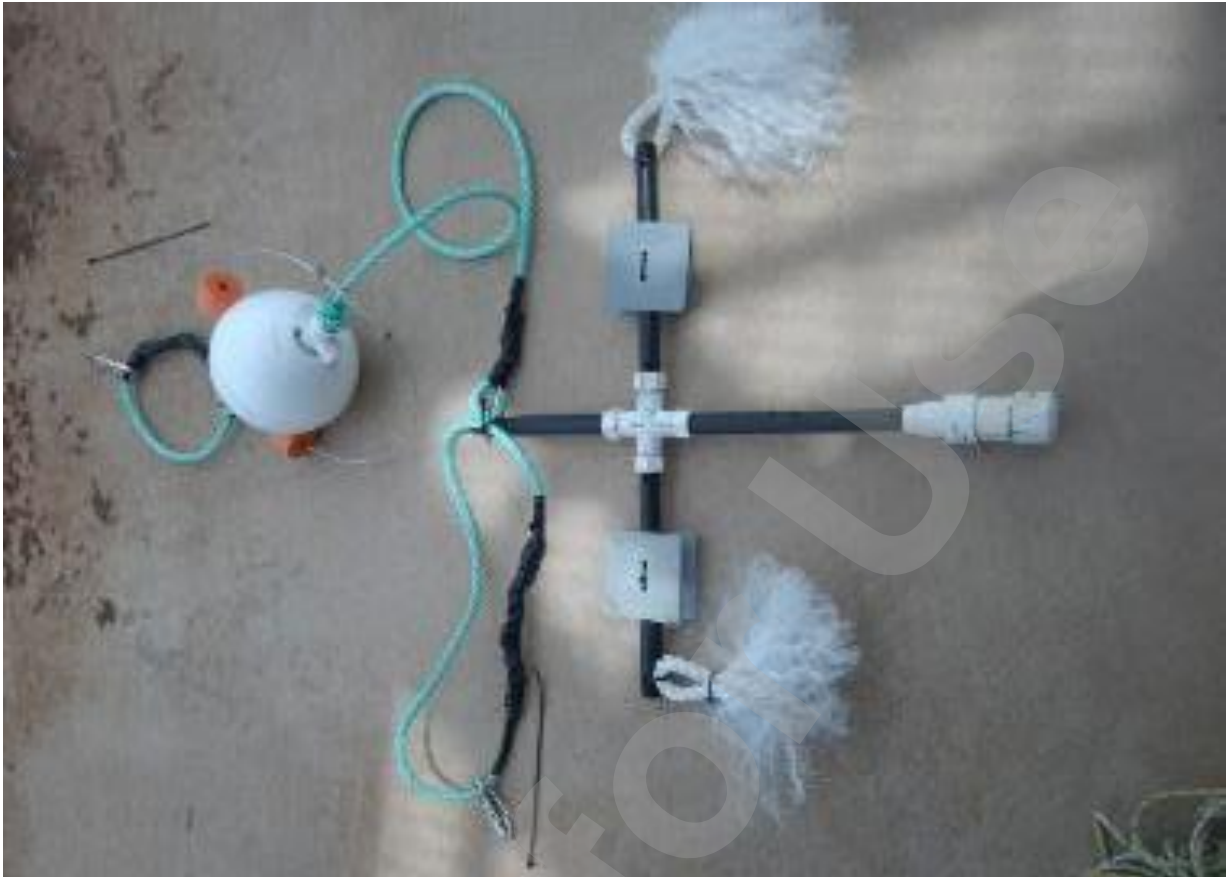
Figure 5-2: Nearshore marine pest ASU

Nearshore monitoring is undertaken to assess the presence/absence of invasive marine species at the Ichthys LNG LPG/condensate product loading jetties (Figure 5-1). The two sites located on the product loading jetties have been incorporated in the wider Darwin Harbour program, managed by NT Aquatic Biosecurity Unit, within the Fisheries Division of the Northern Territory Department of Industry, Tourism and Trade (NT DITT). NT DITT provide the artificial settlement units (ASUs; Figure 5-2) for INPEX to deploy at the jetties. Each ASU consists of four settlement plates (back-to-back) and two rope mops.

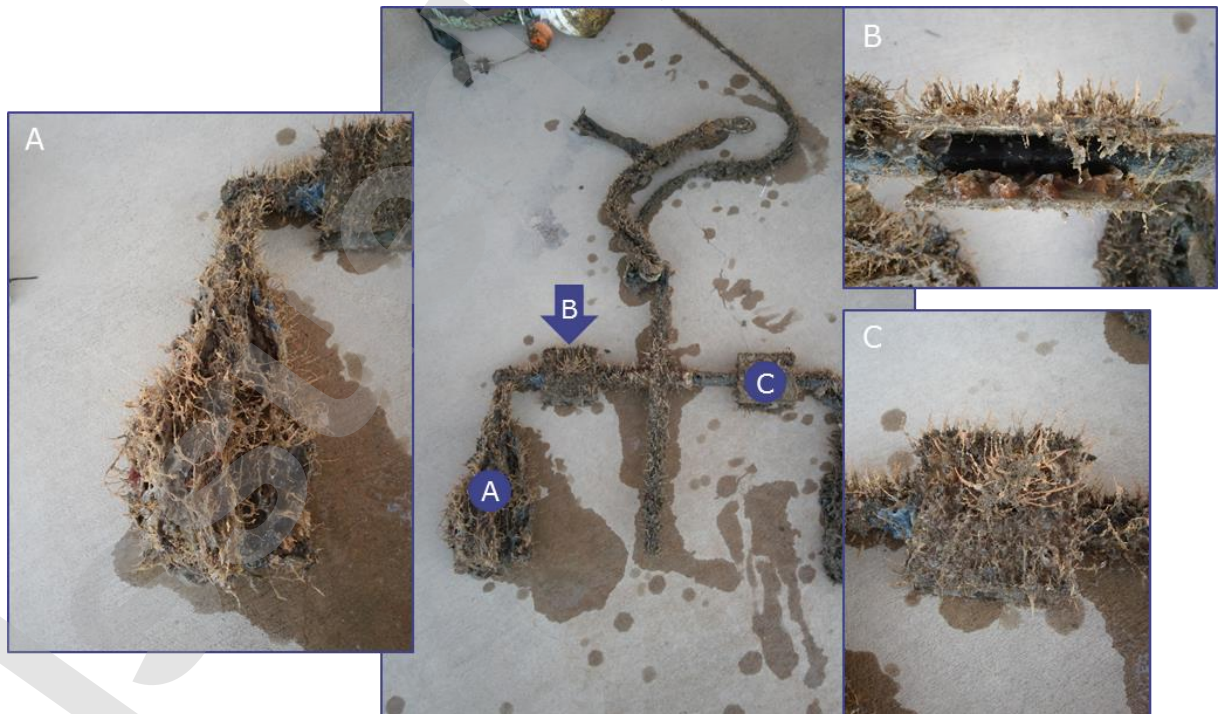
Photo-monitoring of ASUs is undertaken monthly with ASUs collected and replaced every fourth month (an example of monitoring photographs is shown in Figure 5-3). Collected ASUs and monthly photos of the traps are sent to NT DITT for species identification.

Figure 5-3: Example of monitoring photographs taken during monthly inspection a) rope mop, b) inside the plates and c) plates surface biofouling conditions

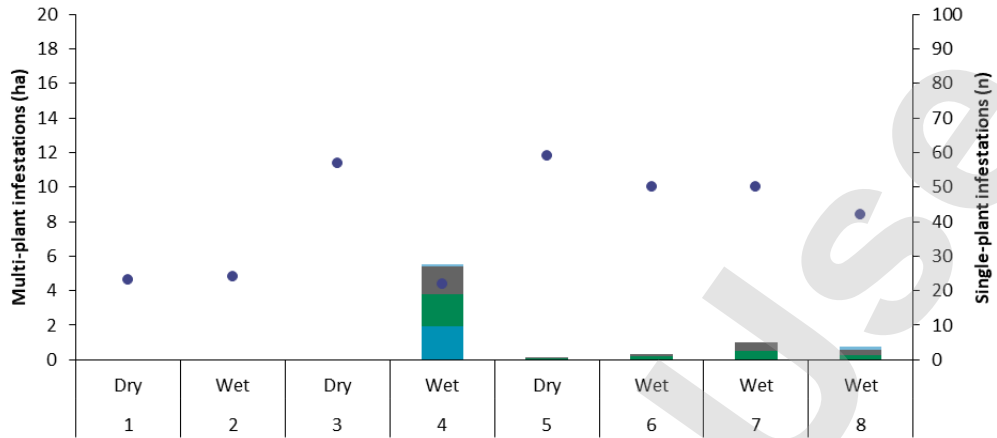
Figure 5-5: Comparison of declared weed infestations between AEMR reporting periods

Favourable growth conditions over the 2021-22 wet season had resulted in significant patches of hyptis establishing with the GEP corridor and Bladin Point road corridor (reflected in Survey 6 results; Figure 5-5). However, Survey 7 and Survey 8 have recorded a steady decrease in multi-plant infestation. However, individual hyptis plants have increased significantly in Survey 8.

Notably, no perennial mission grass was recorded in Survey 8. Patches of this species are a very high priority for control.

Overall weed management measures undertaken during the reporting period were adequate. It is recommended that a gamba grass treatment program is implemented in Section 1888, the operations area and the production area immediately following each wet season until it has been sufficiently controlled.

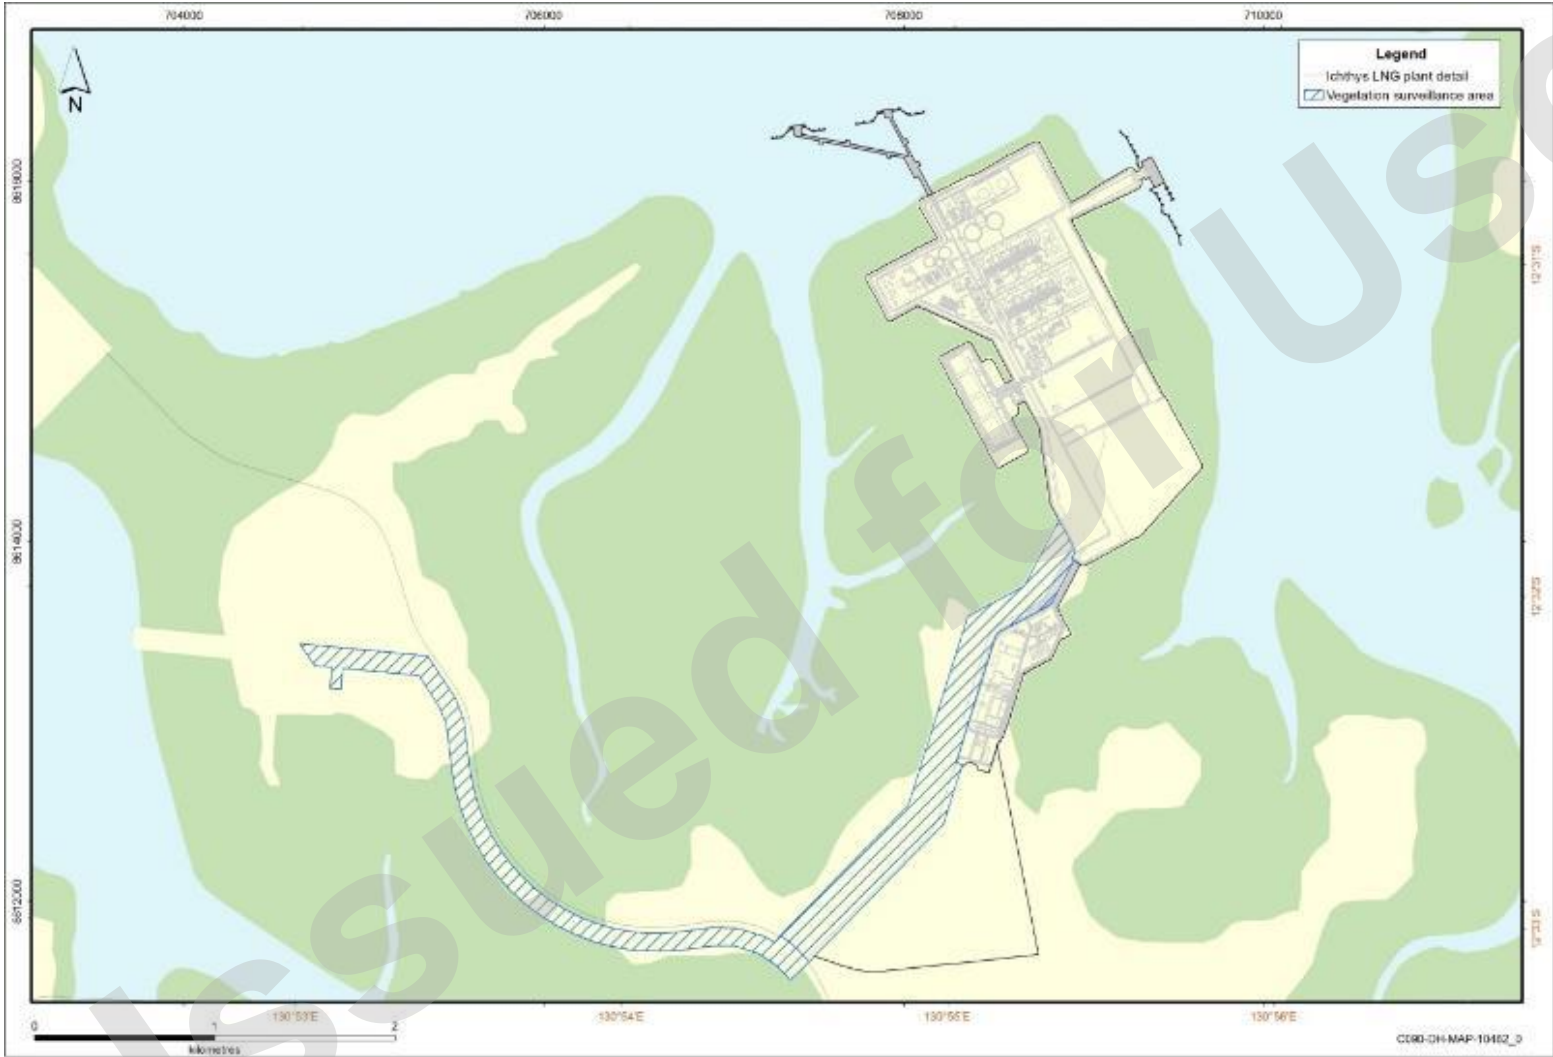
Figure 5-6: Vegetation surveillance survey area

A vegetation surveillance survey (Survey 4) was performed in accordance with the Northern Territory guidelines and field methodology for vegetation survey and mapping (Brocklehurst et al. 2007). Key parameters assessed during the surveillance survey are shown in Table 5-4. Rehabilitation categories (discussed in Section 5.6.2) are provided in Table 5-5. The area surveyed are shown in Figure 5-6.
